# Memorandum

**To:** NHPS Finance and Operations Committee  
**From:** Thomas Smith  
**Re:** Approval of Amendment #3 to Consultant Agreement – SSRCx  
 Helene Grant School Project  
**Meeting Date:** April 19, 2021

**THIRD AMENDMENT TO AGREEMENT  
FOR CONSULTANT SERVICES DATED DECEMBER 18, 2013  
BY AND BETWEEN THE CITY OF NEW HAVEN BOARD OF EDUCATION  
("OWNER") AND SSRcx  
("CONSULTANT")**

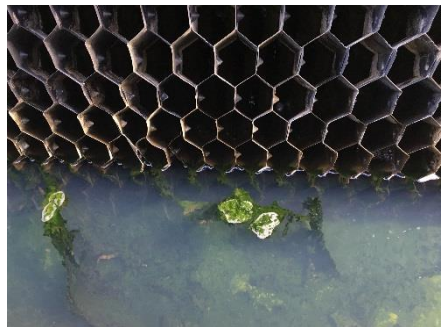
- c. Item 0066: The cooling tower fill has been cleaned but the basin of the cooling tower has algae growing on the fill and in the basin. The biocide program should be reviewed to ensure it is working properly.

**Figure 1: This is referring to item  
0066 - Algae in the basin of the  
tower.**
