**NEW HAVEN PUBLIC SCHOOLS  
NEW HAVEN, CONNECTICUT**

**Long Range Facilities Planning Study**  
**Summary of Findings & Recommendations**

**Final 12-04-23**

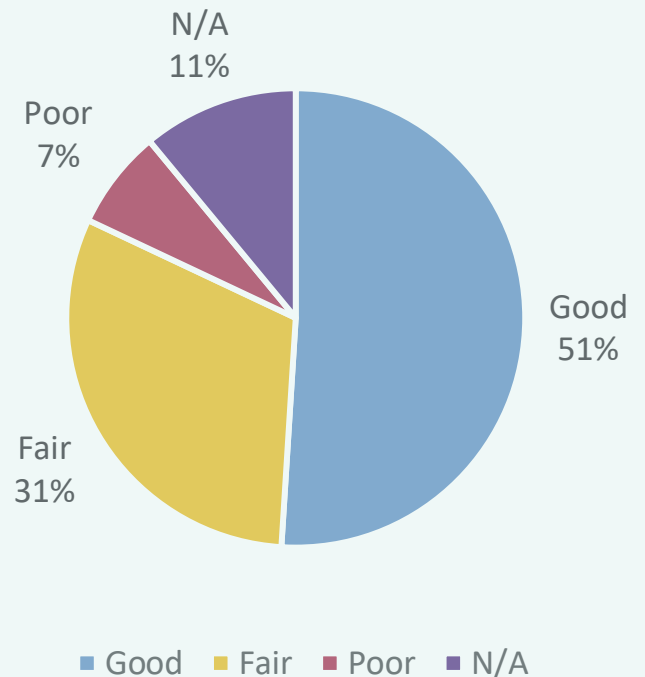
### School Amenity Conditions

The overall condition of the amenities (playgrounds, athletic fields, etc.) offered at each school also varied and were categorized in the same manor. The breakdown of the overall school site amenities are as follows:

Please refer to Appendix F of this report to see a detailed breakdown of each school's site evaluation.

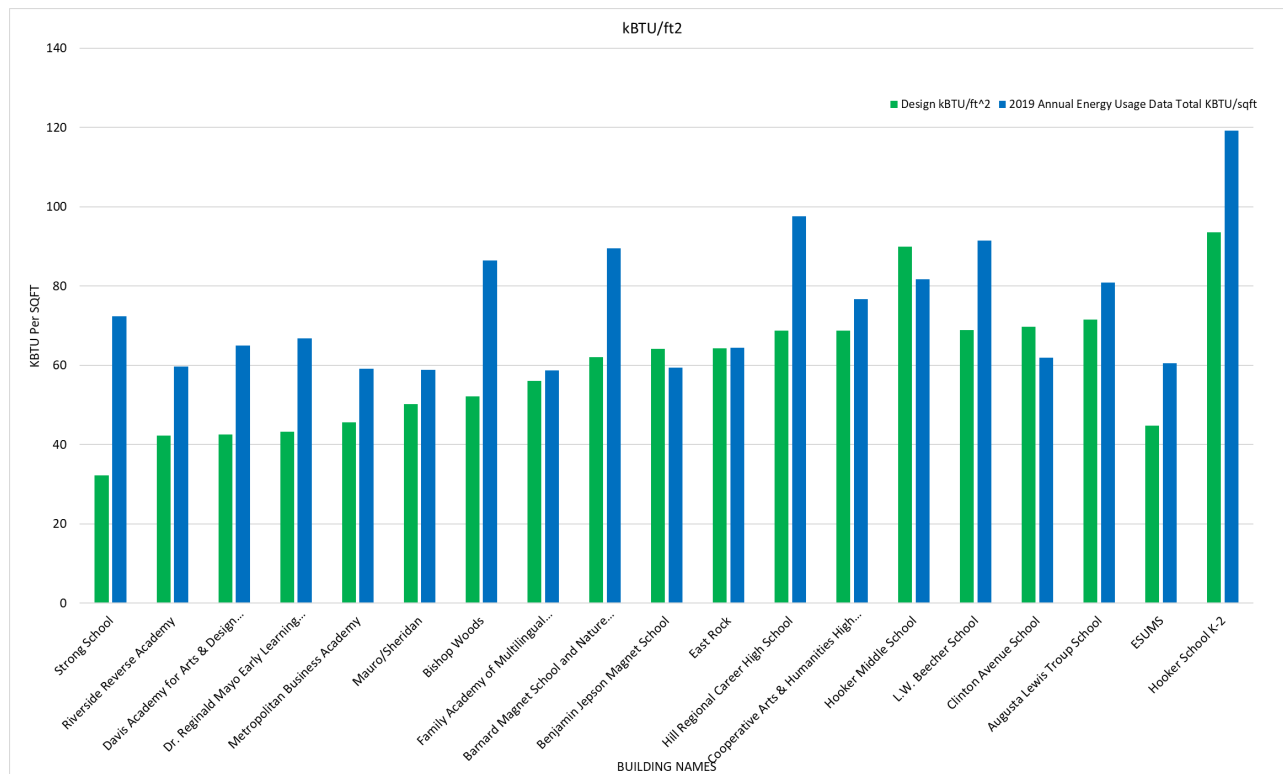
Graph 1: kBTU/ft<sup>2</sup> for Modeled Schools

- Bills were missing for various schools and thus energy usage was assumed in these cases. These assumptions are marked in the individual school energy tables located in the appendices in yellow.

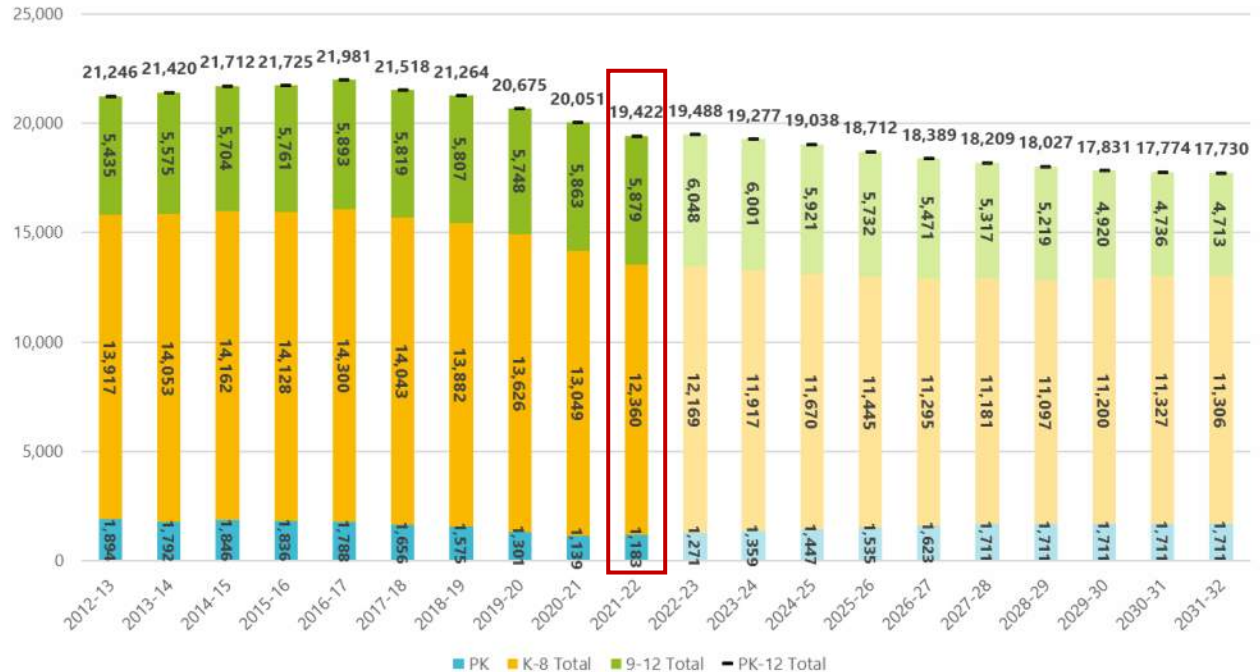
New Haven Historic & Projected PK-12 Enrollment by Grade Level  
2012-13 to 2031-32 (Medium Scenario)

- **Overall PK-12 enrollment is projected to continue declining, however at a slower rate over the next decade with some overall growth in the first year.**
- This growth is due to PK enrollment beginning to rebound to pre-pandemic levels, in addition to a slight increase in high school enrollment.
- Additionally, K enrollment is projected to rebound, after averaging 1,184 the last two years.

- PK-8 enrollment is projected to decline through the first 5-years and then stabilize through the last 5-years, averaging 12,933 students
- 9-12 enrollment is projected to peak at over 6,000 students for 2022-23, then decline significantly, decreasing by 22.1% over the ten-year period. This decline is largely due to smaller cohorts matriculating into high school and reduced enrollment in regional inter district magnet students

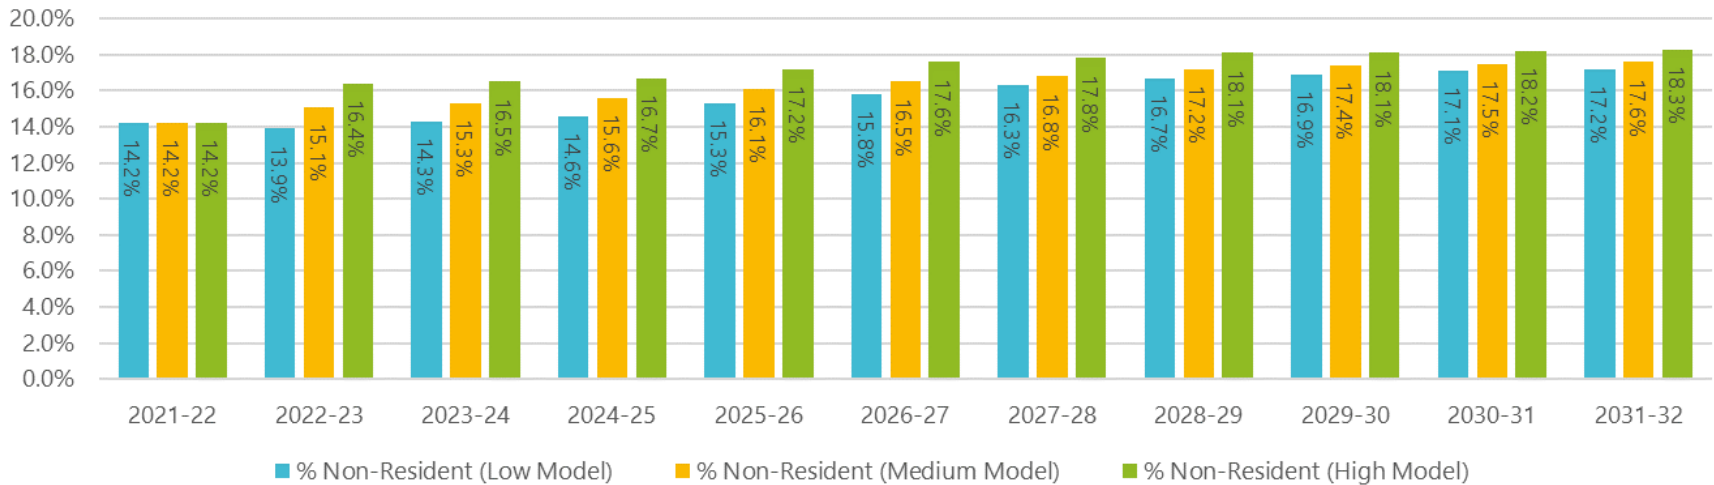
Percent Non-Resident Students by Projection Model

- Low, Medium, and High models for non-resident students differ based on the **proportion of projected non-resident students** entering the district
- Should recruitment and enrollment of regional interdistrict magnet students change over the next decade, the three models provide a range of likely enrollments.

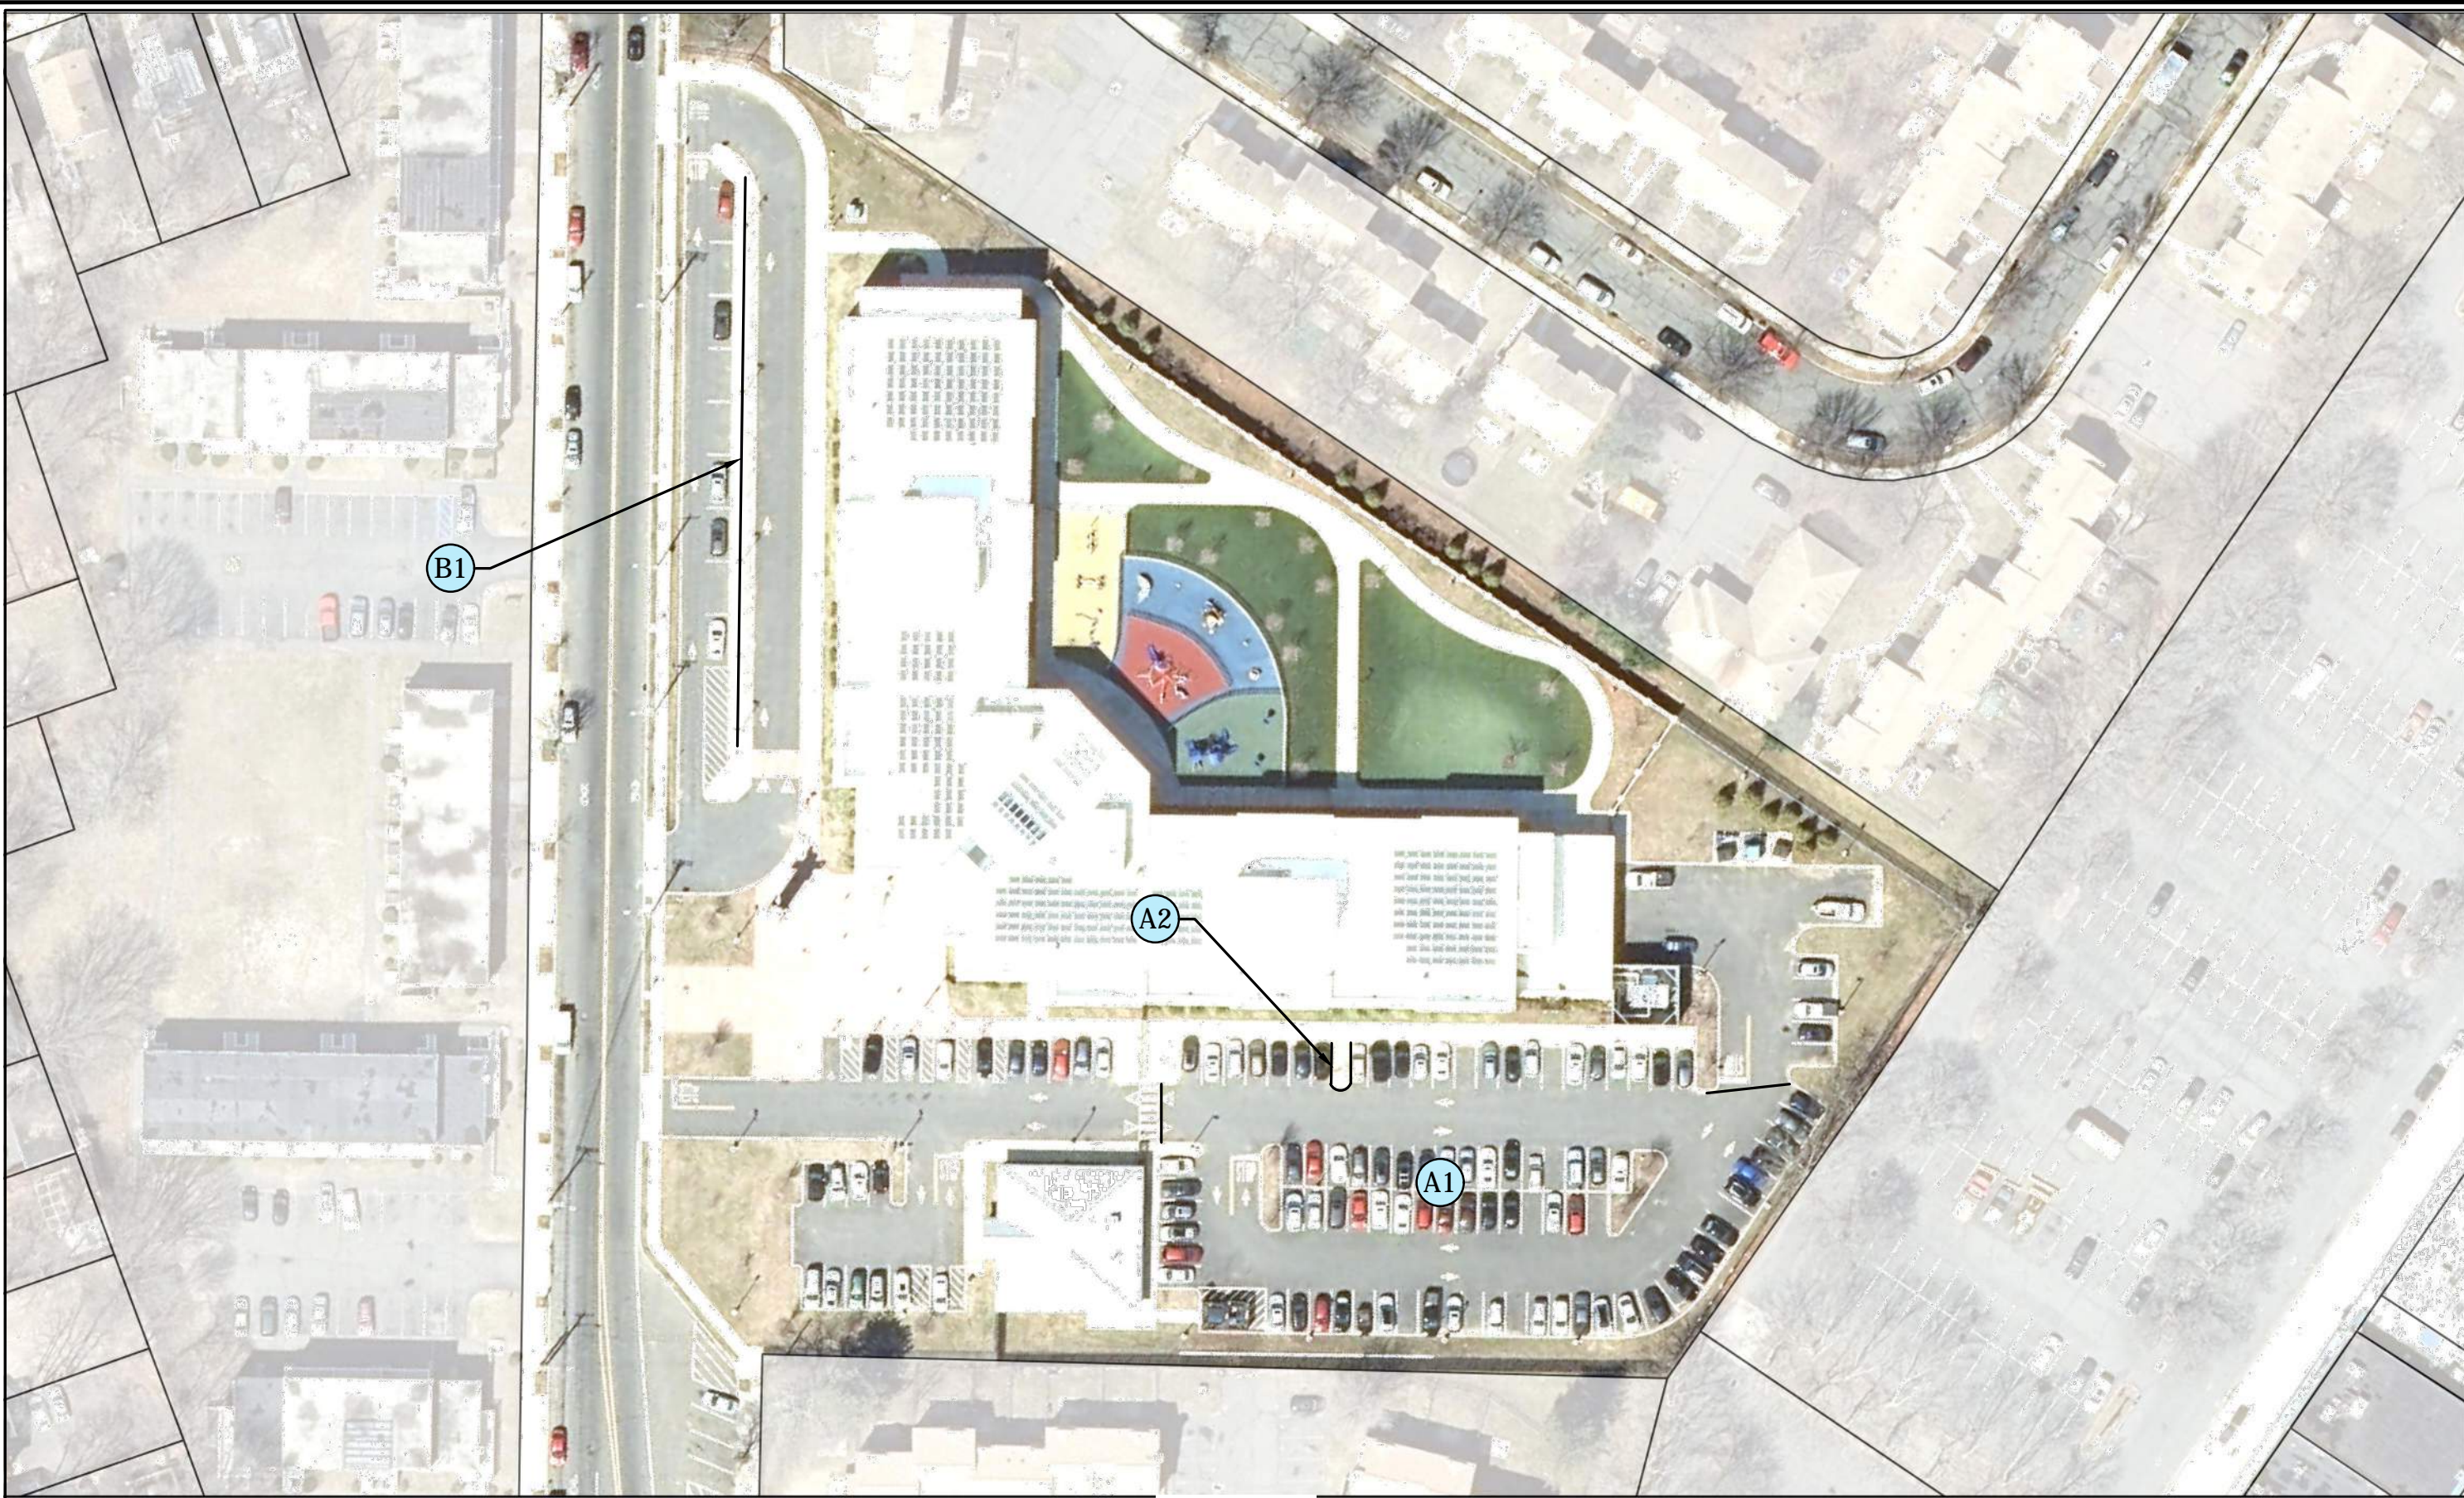
Dr. Reginald Mayo Early Learning Childhood School

PRIORITY	TIMELINE	EXPLANATION
1	Immediately	Critical- Extremely Worn or Damaged. Replace Immediately (Life Safety)
2	1-2 years	Worn- Showing Moderate Damage and Wear. Nearing the end of it's Life Cycle
3	3-5 years	Fair- Normal Wear for the Age.
4	6-10 years	Good- Little Visable Wear. At the Beginning of it's Life Cycle

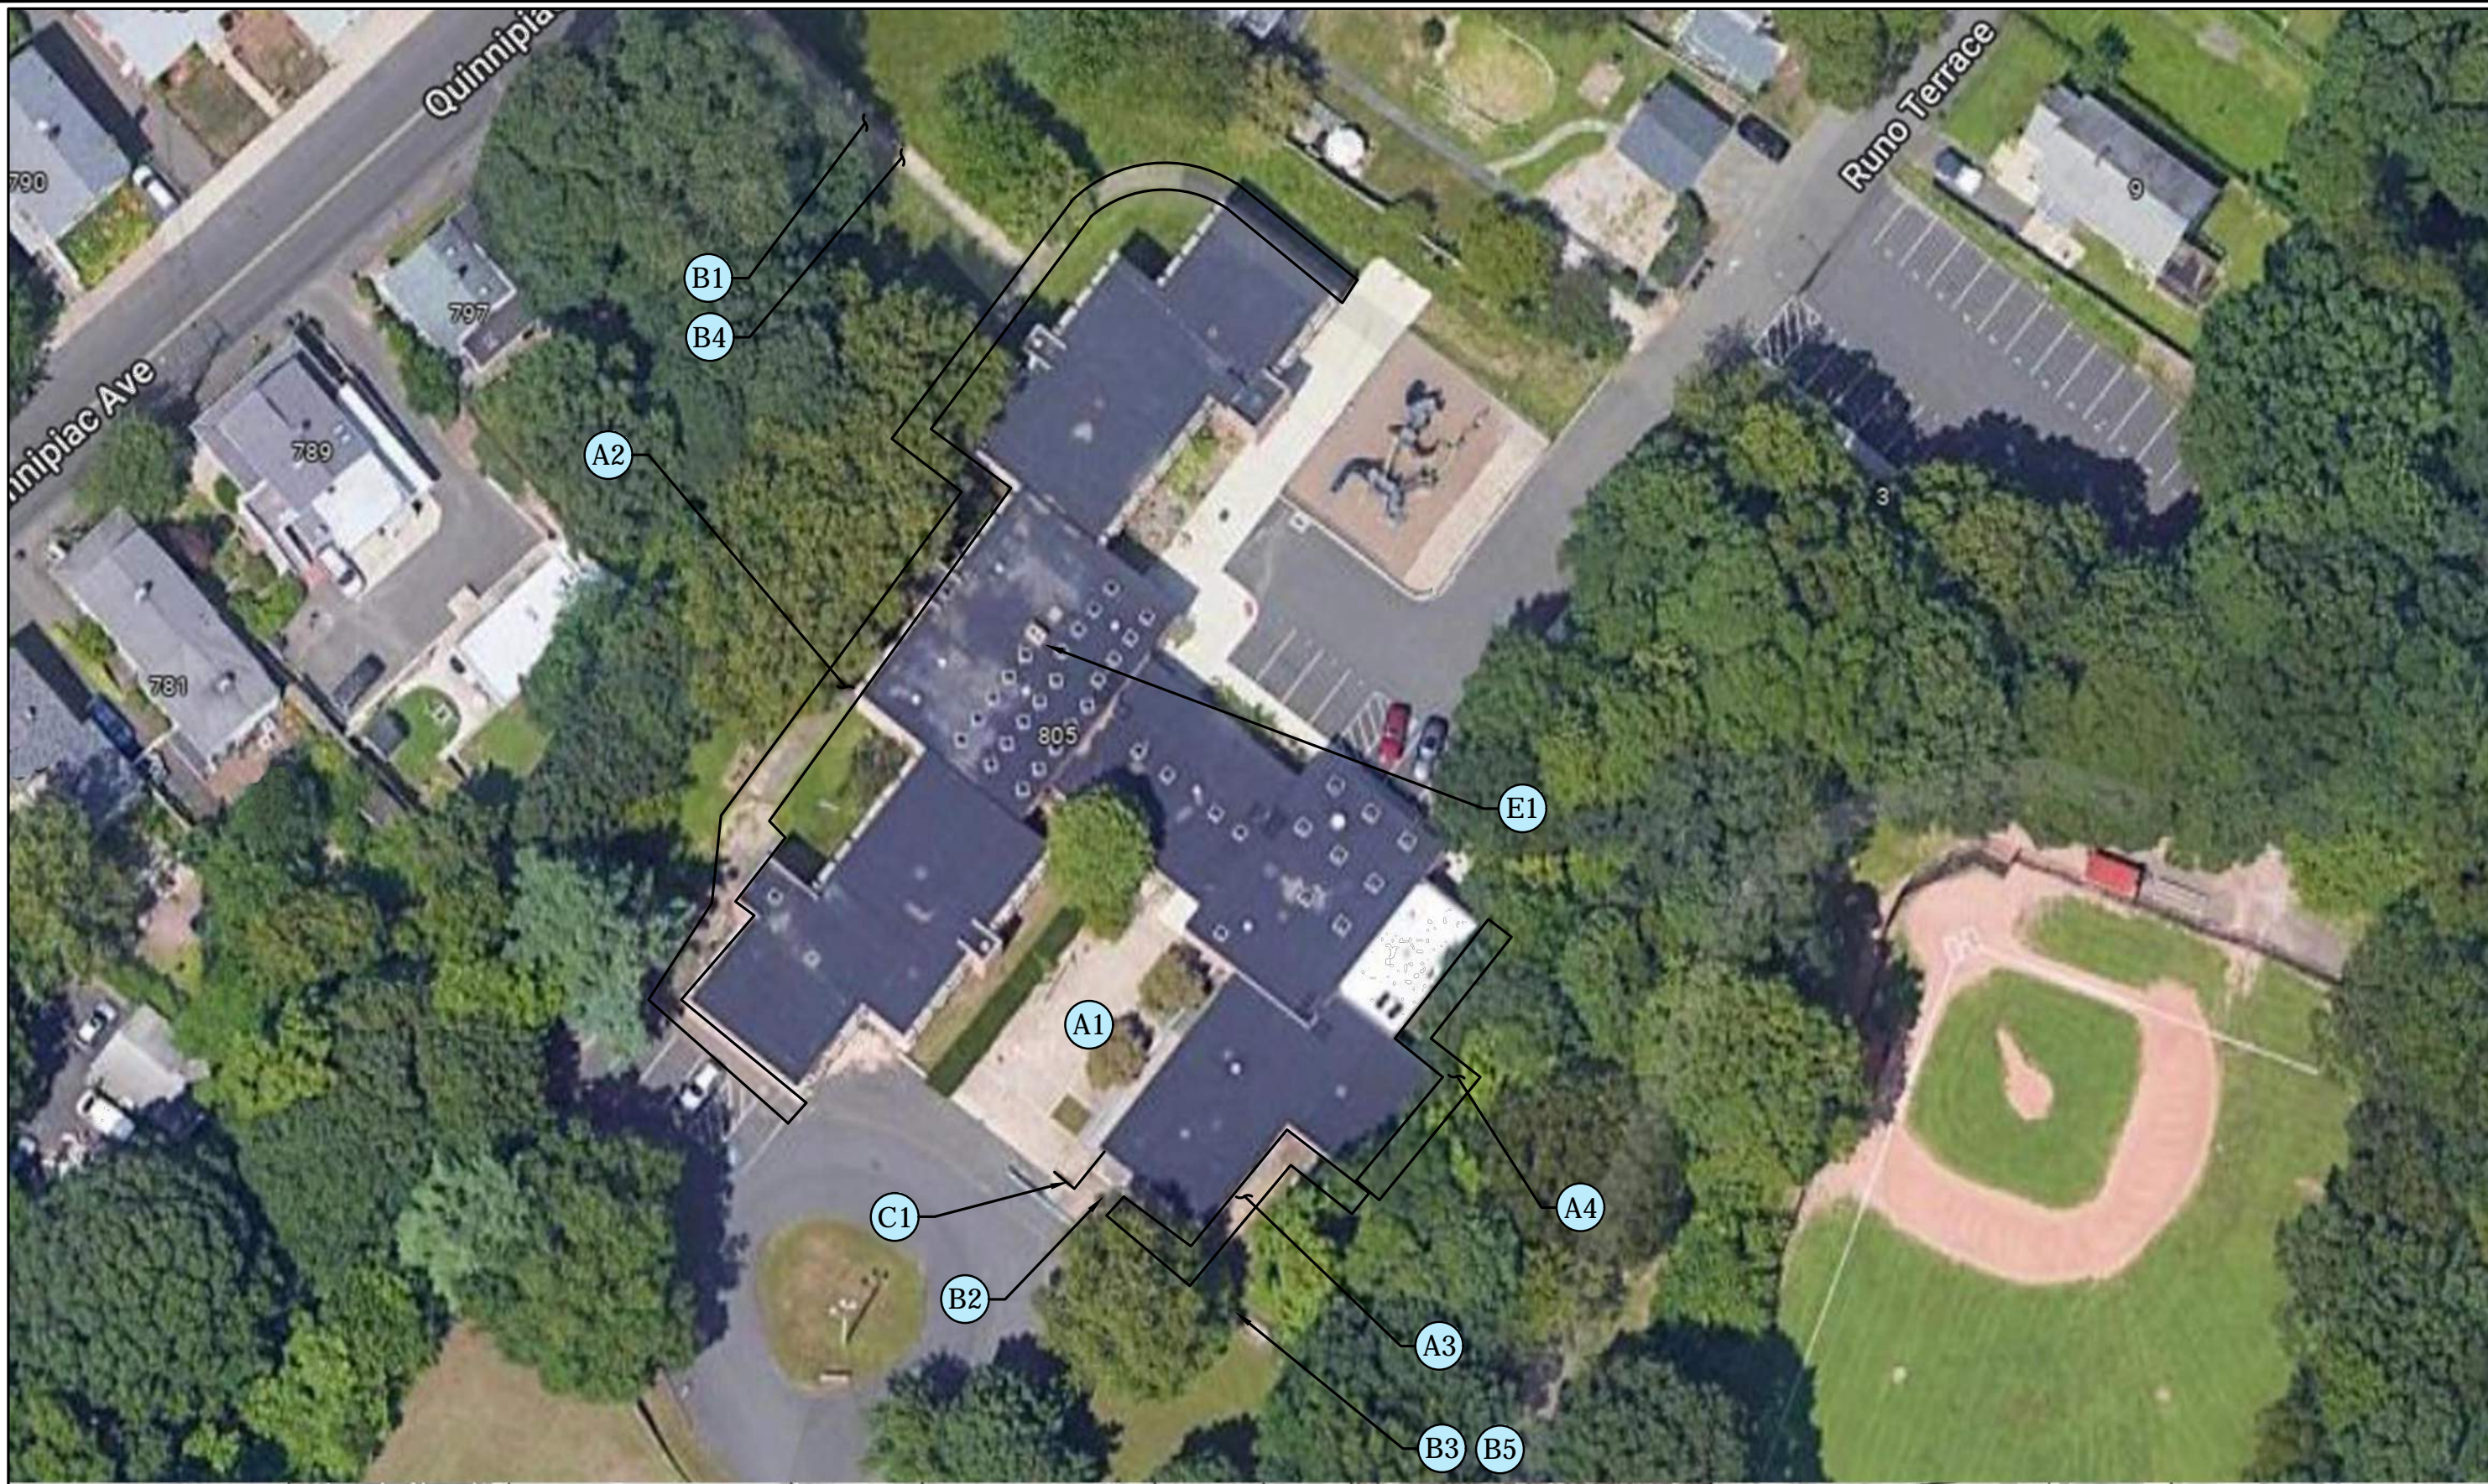
QUINNIPIAC STEM MAGNET SCHOOL

ITEM	CORRECTION	PRIORITY	REASON	LOCATION	NOTES
			PRIORITY	TIMELINE	EXPLANATION
			1	Immediately	Critical- Extremely Worn or Damaged. Replace Immediately (Life Safety)
			2	1-2 years	Worn- Showing Moderate Damage and Wear. Nearing the end of it's Life Cycle
			3	3-5 years	Fair- Normal Wear for the Age.
			4	6-10 years	Good- Little Visable Wear. At the Beginning of it's Life Cycle

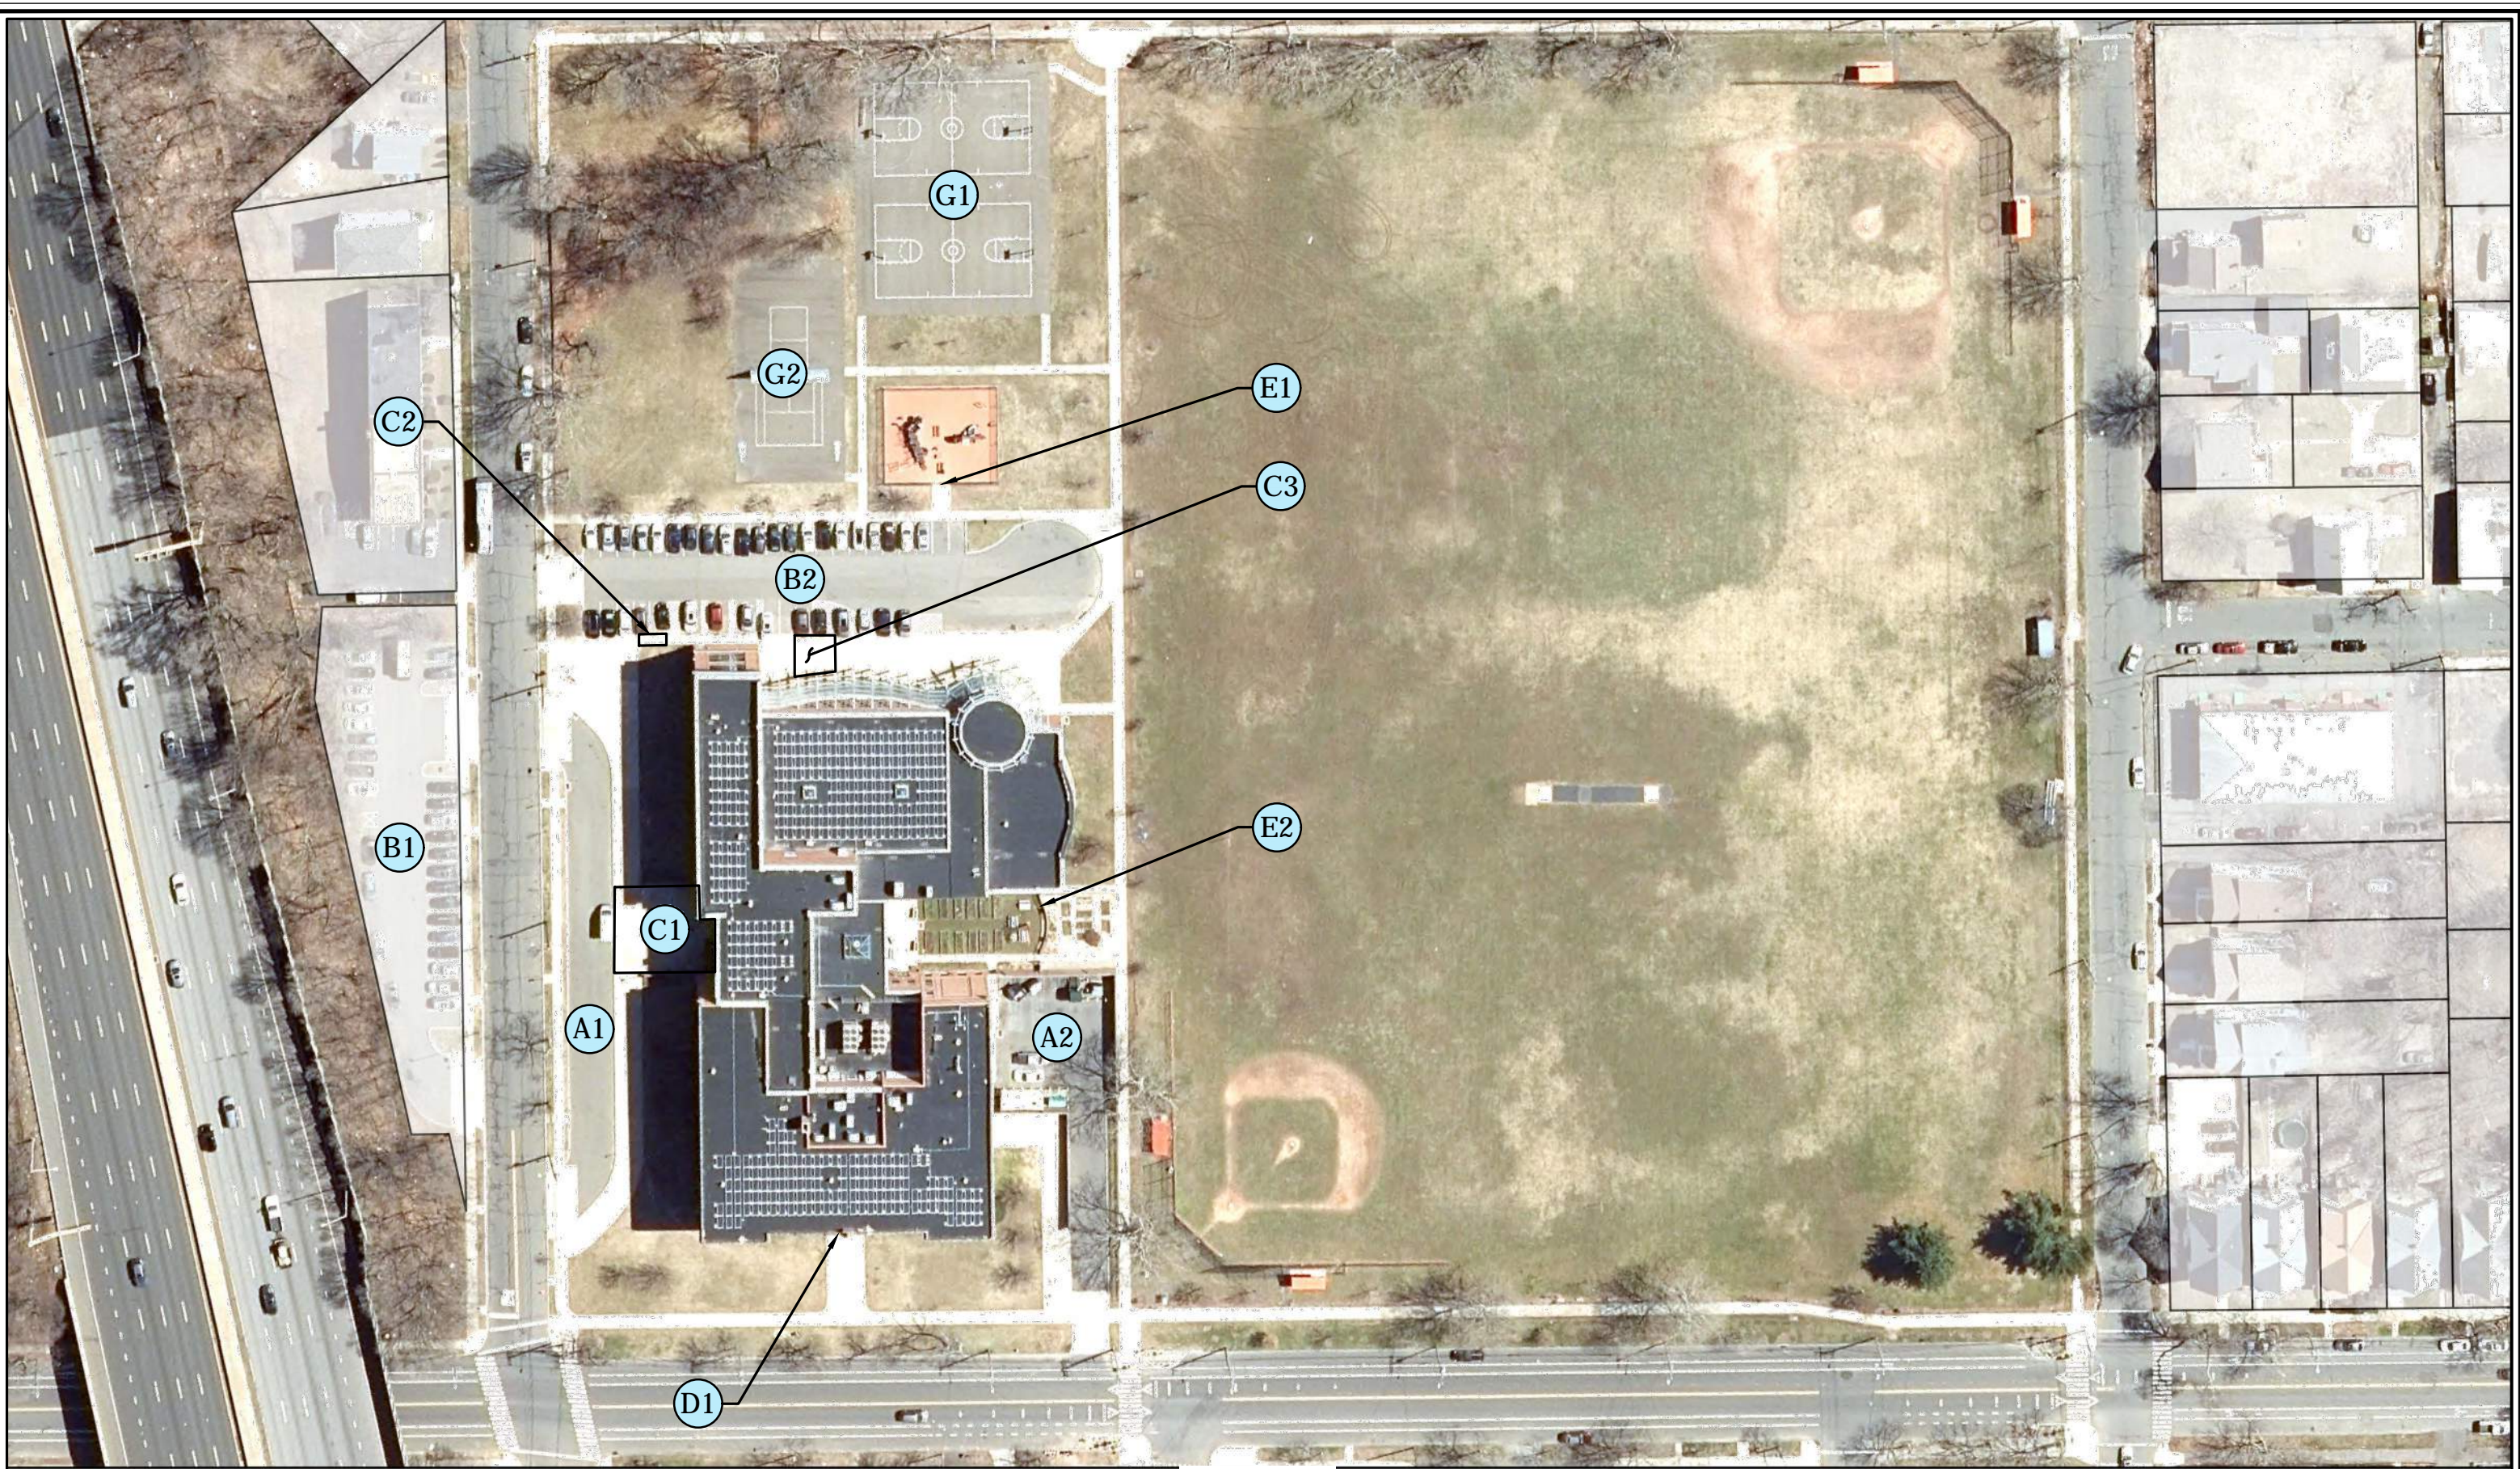
Clinton Ave School

PRIORITY	TIMELINE	EXPLANATION
1	Immediately	Critical- Extremely Worn or Damaged. Replace Immediately (Life Safety)
2	1-2 years	Worn- Showing Moderate Damage and Wear. Nearing the end of it's Life Cycle
3	3-5 years	Fair- Normal Wear for the Age.
4	6-10 years	Good- Little Visable Wear. At the Beginning of it's Life Cycle

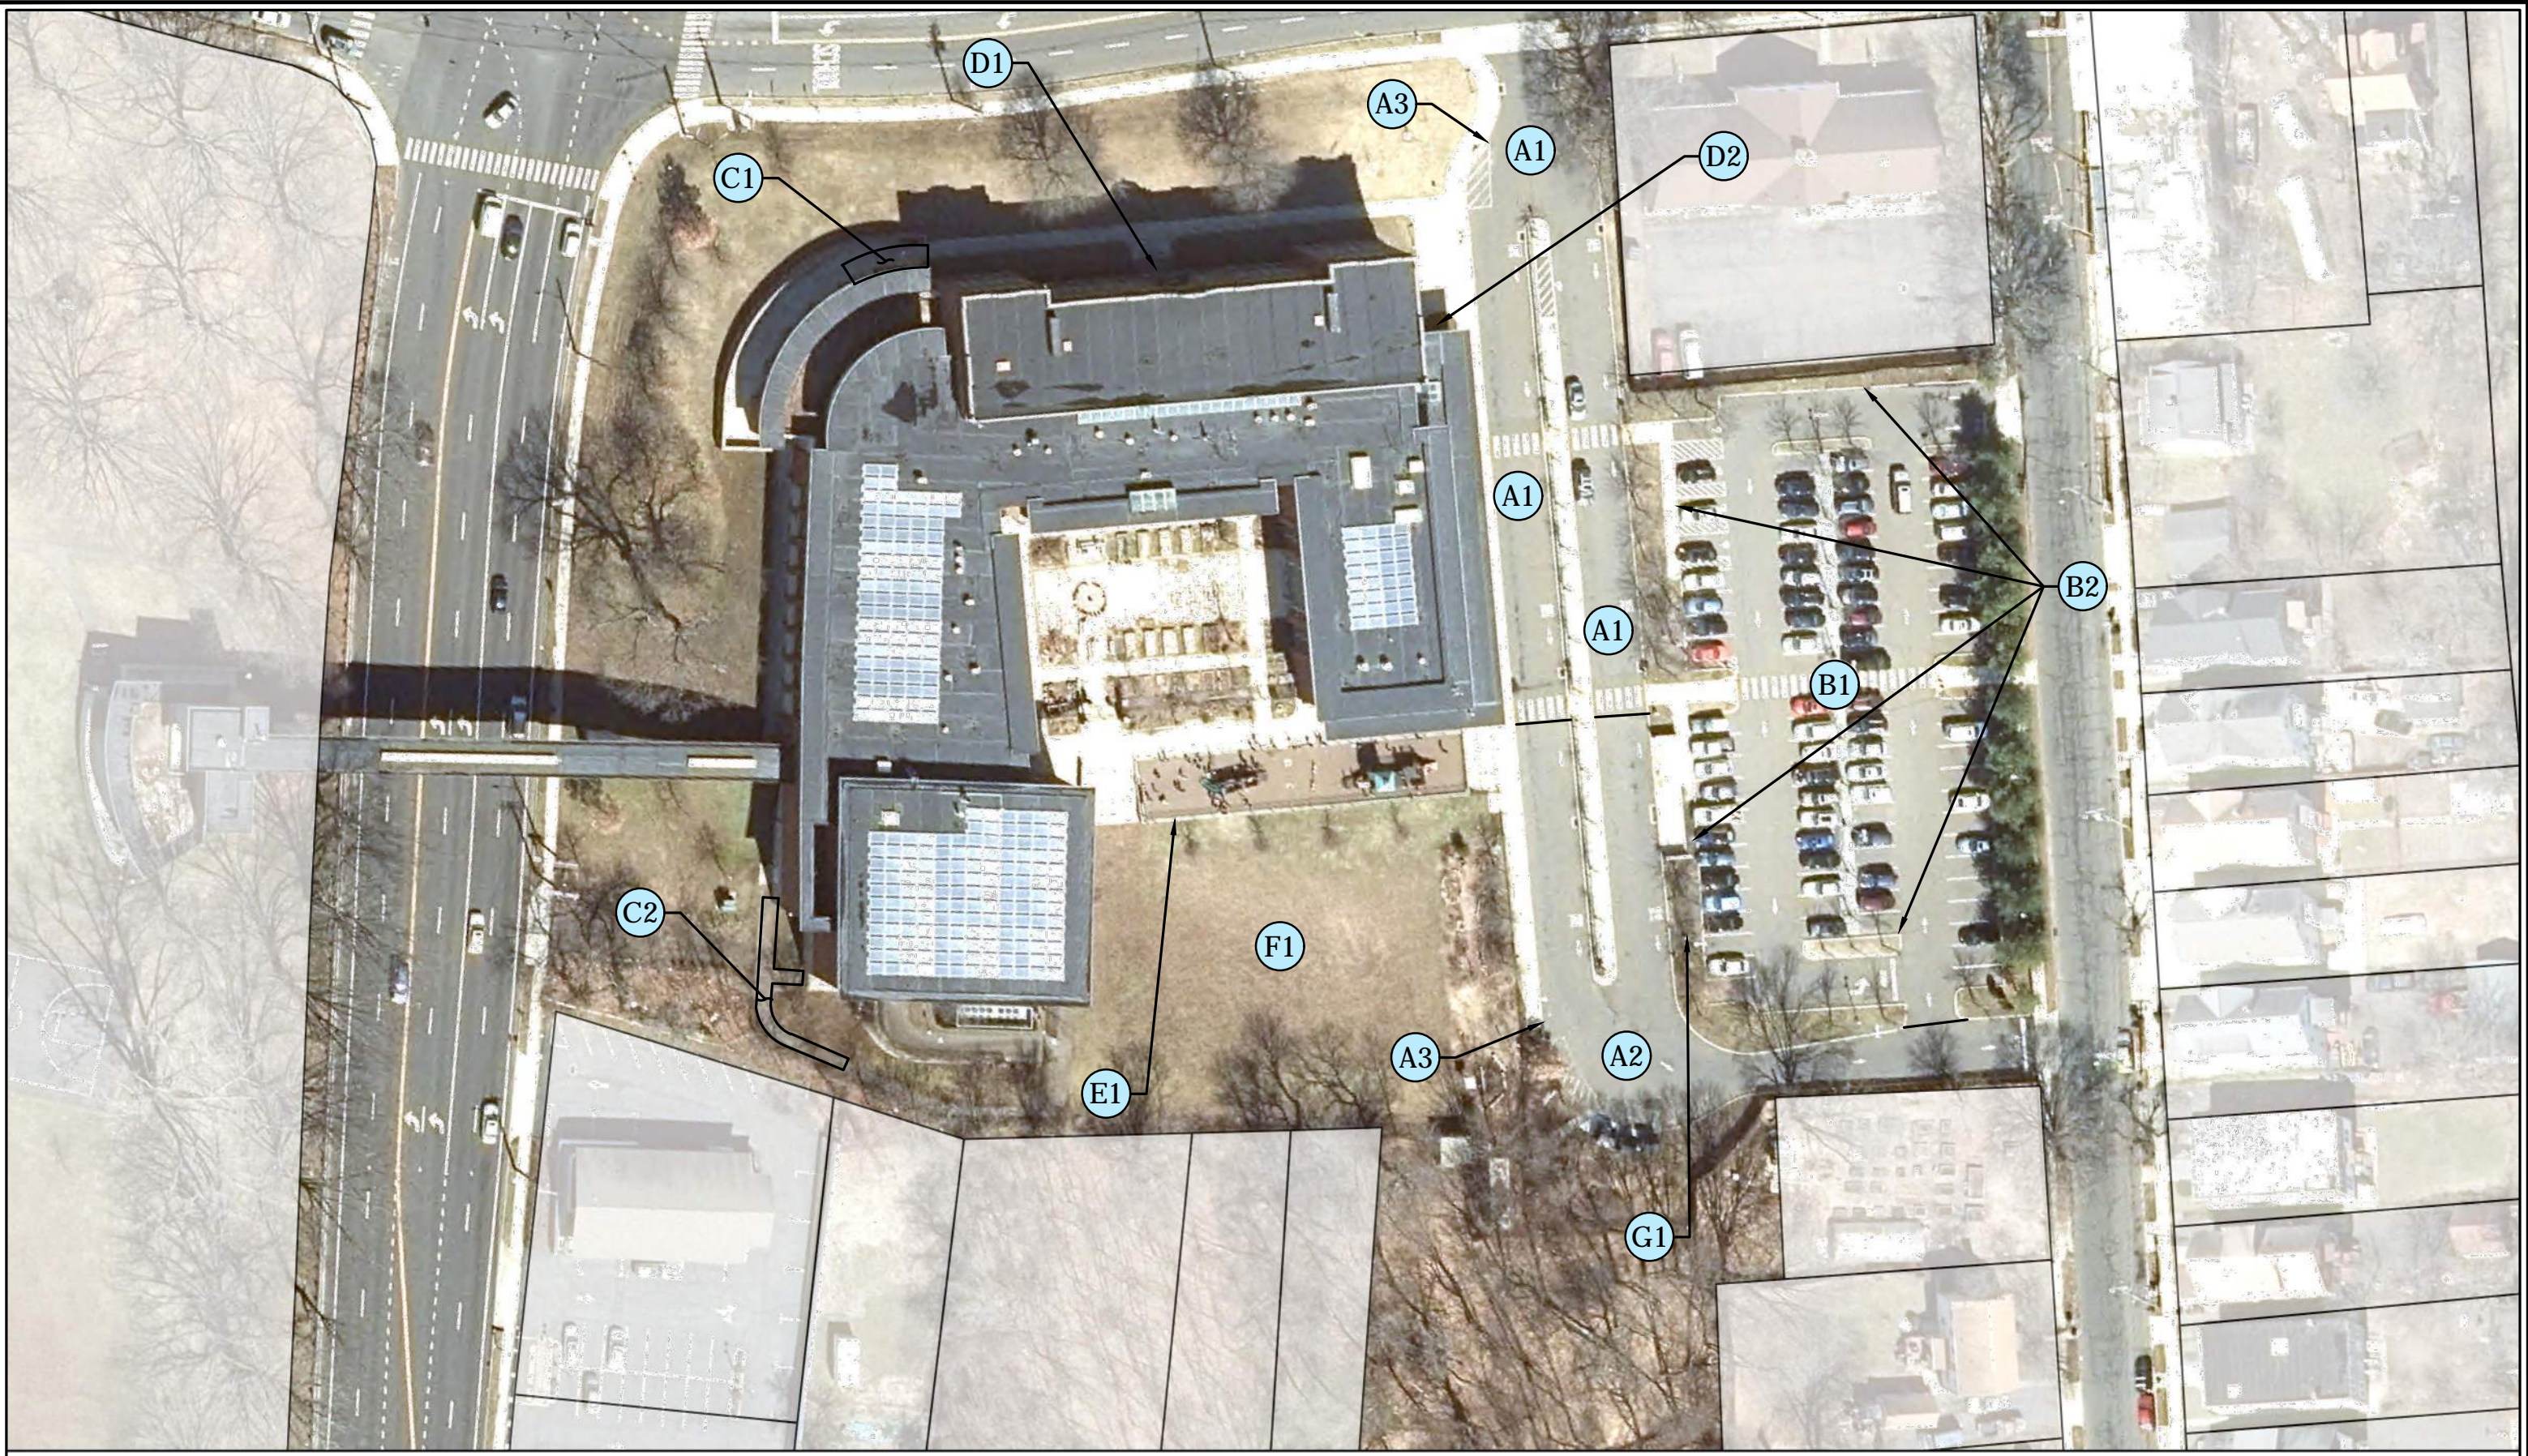
Barnard Environmental Science & Technology School

PRIORITY	TIMELINE	EXPLANATION
1	Immediately	Critical- Extremely Worn or Damaged. Replace Immediately (Life Safety)
2	1-2 years	Worn- Showing Moderate Damage and Wear. Nearing the end of it's Life Cycle
3	3-5 years	Fair- Normal Wear for the Age.
4	6-10 years	Good- Little Visable Wear. At the Beginning of it's Life Cycle

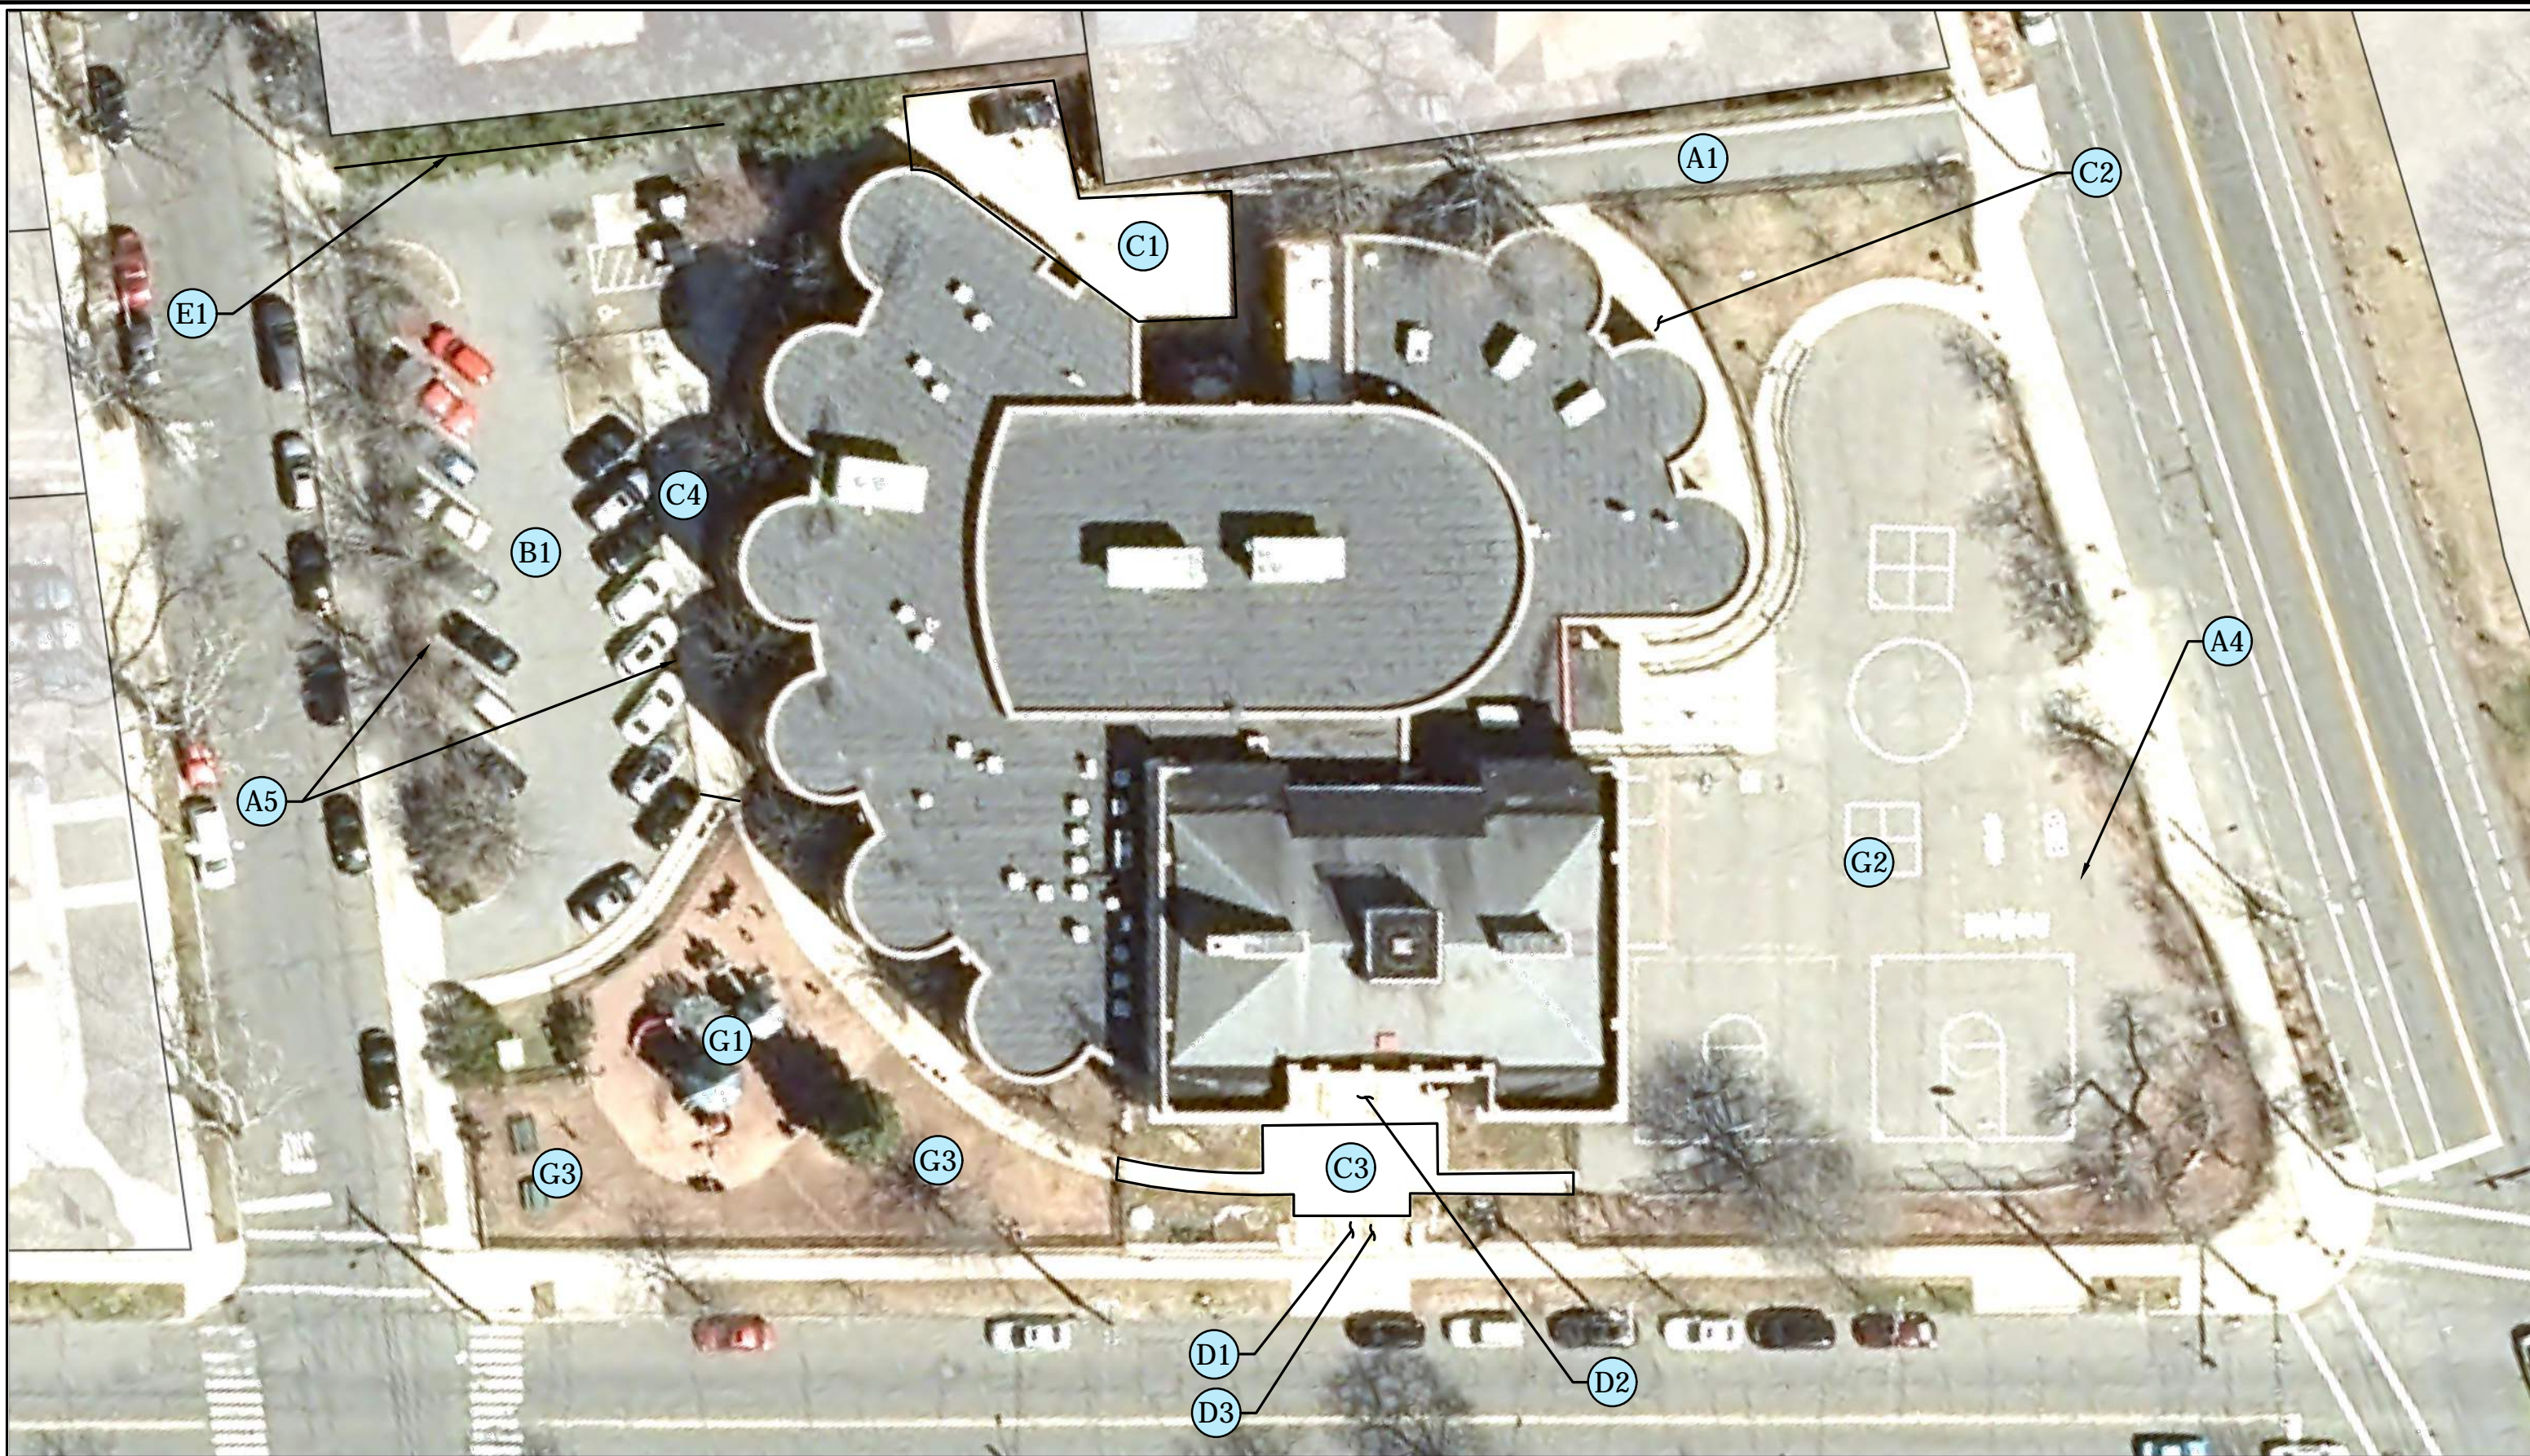
Edgewood Creative Thinking Through STEAM Magnet School

PRIORITY	TIMELINE	EXPLANATION
1	Immediately	Critical- Extremely Worn or Damaged. Replace Immediately (Life Safety)
2	1-2 years	Worn- Showing Moderate Damage and Wear. Nearing the end of it's Life Cycle
3	3-5 years	Fair- Normal Wear for the Age.
4	6-10 years	Good- Little Visible Wear. At the Beginning of it's Life Cycle
